Manhole Inspection Summary

Manhole # S29UU1008MH

Insp Date: **3/6/07 9:32 AM**

Location Address: **5001 BOXHILL LN**

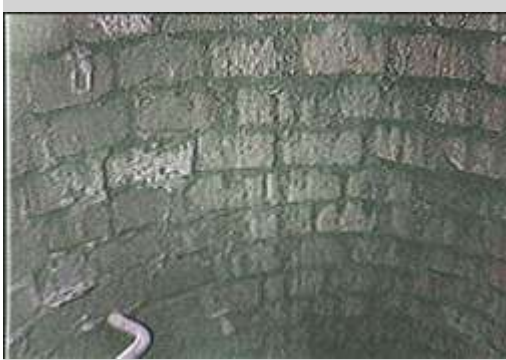
Defect

Bench debris.

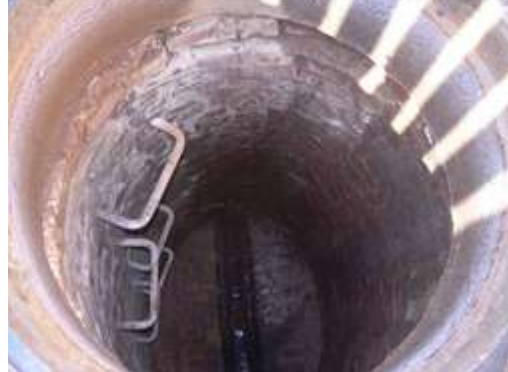
Defect

Corbel deterioration and infiltration.

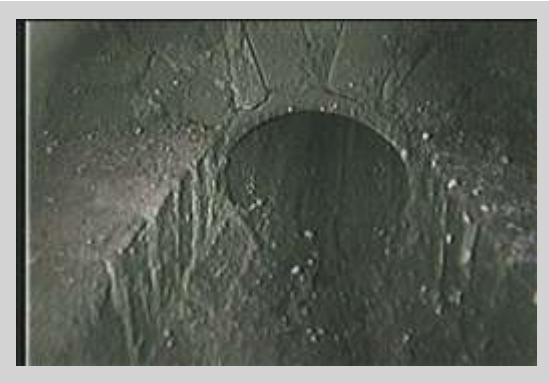
8 in. Circular Gravity Sewer Pipe Out @ 12 O'Clock

Infiltration: **None** Pipe Seal Cond: **Cracked**

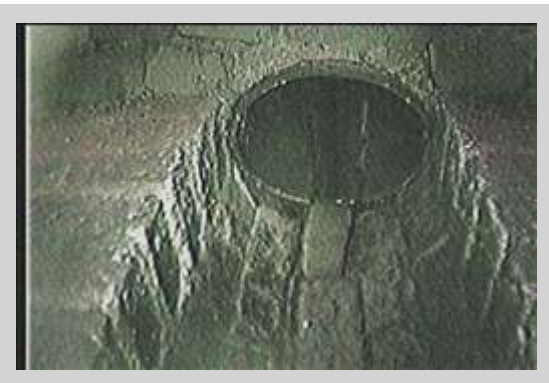
8 in. Circular Gravity Sewer Pipe In @ 6 O'Clock

Infiltration: **Evidence** Pipe Seal Cond: **Cracked**
